**BRIDGE 918 ON S.R. 30 AT REYNOLDS POND
BROADKILN HUNDRED, SUSSEX COUNTY, DELAWARE
PROJECT SUMMARY TO SEPTEMBER 28, 2007**

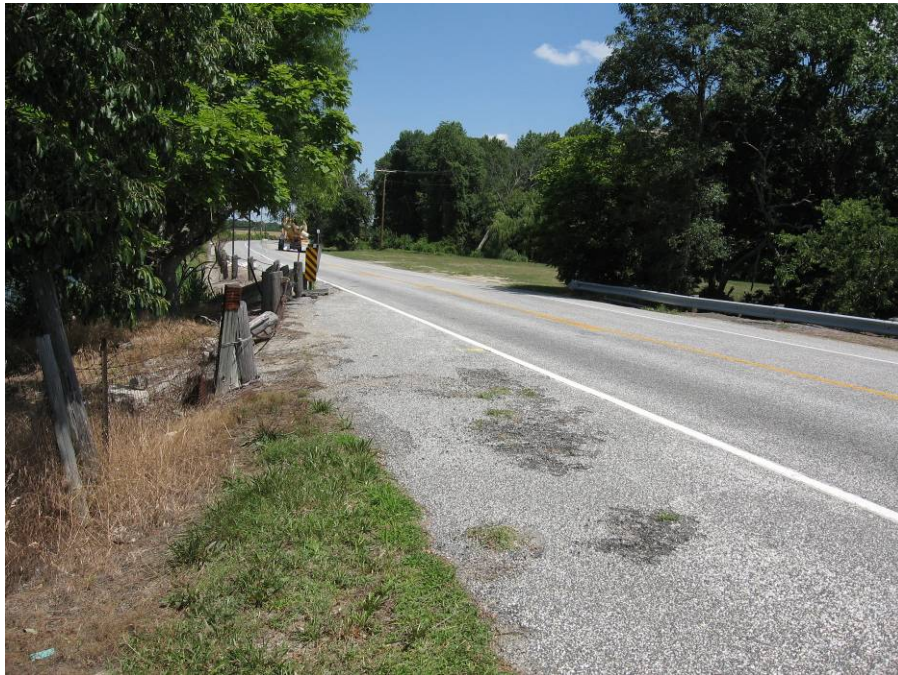
Photograph 1. Bridge 918 project area prior to demolition of ca. 1925 bridge, facing north.

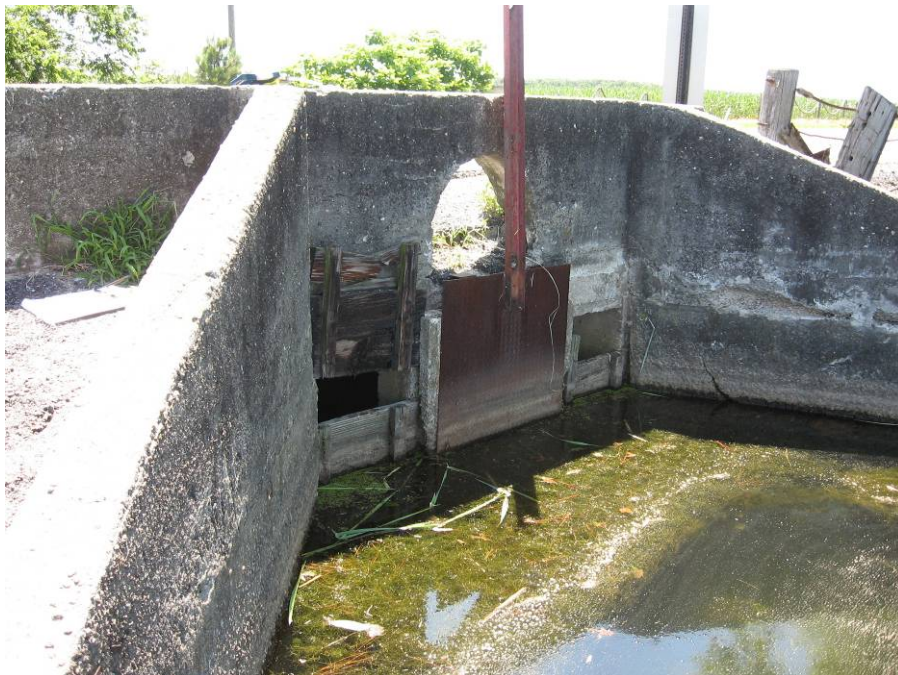
Photograph 2. West side of ca. 1925 bridge showing gate, facing southeast.

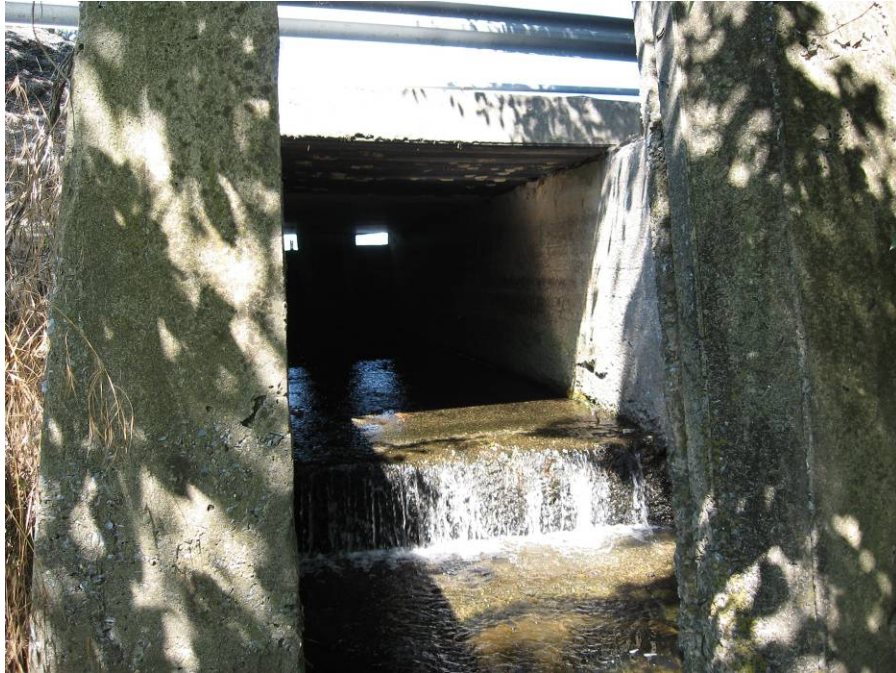
Photograph 3. East side of ca. 1925 bridge showing spillway opening, facing west.

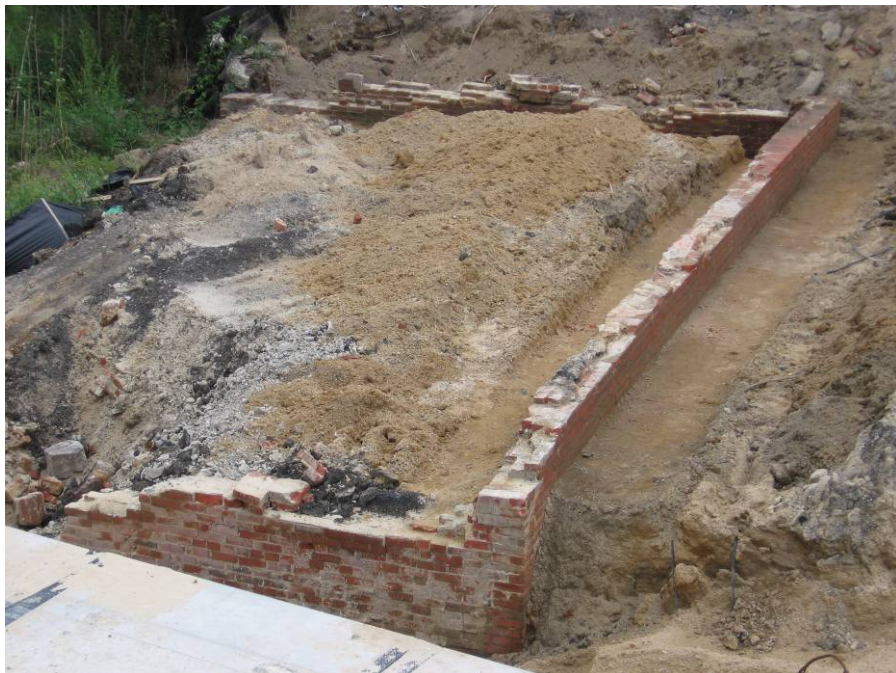
Photograph 4. North, west, and south brick mill foundation walls, facing south/southeast.

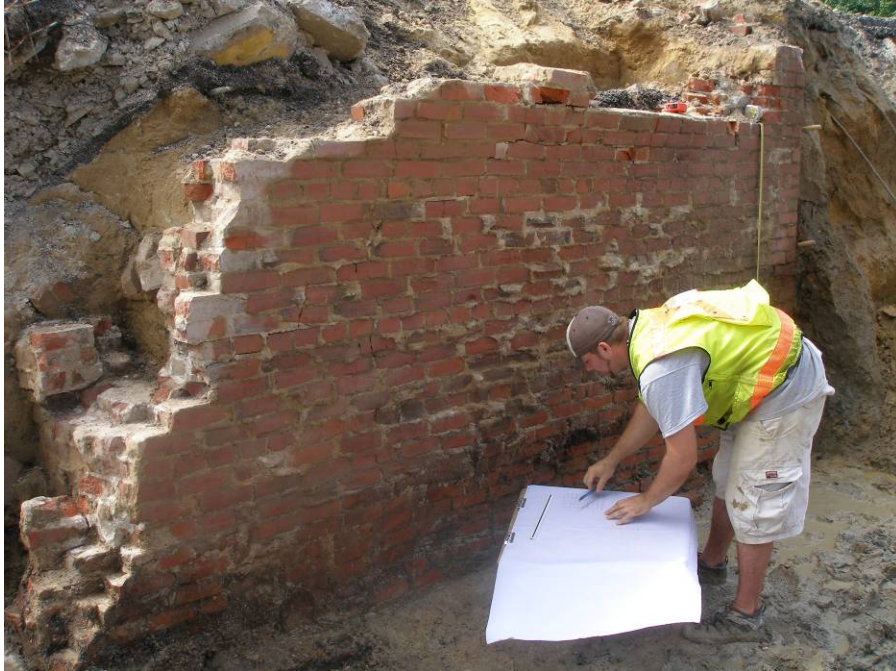
Photograph 5. Mapping north brick mill foundation wall, facing south/southwest.

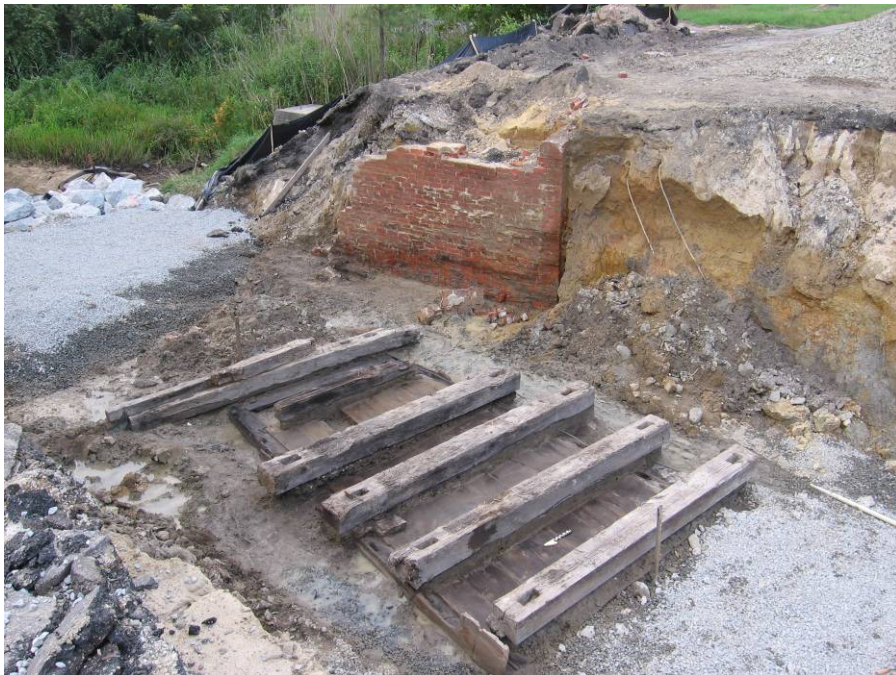
Photograph 6. East half of wood structure after exposure, facing southeast. Note north brick mill foundation wall at top of photograph.

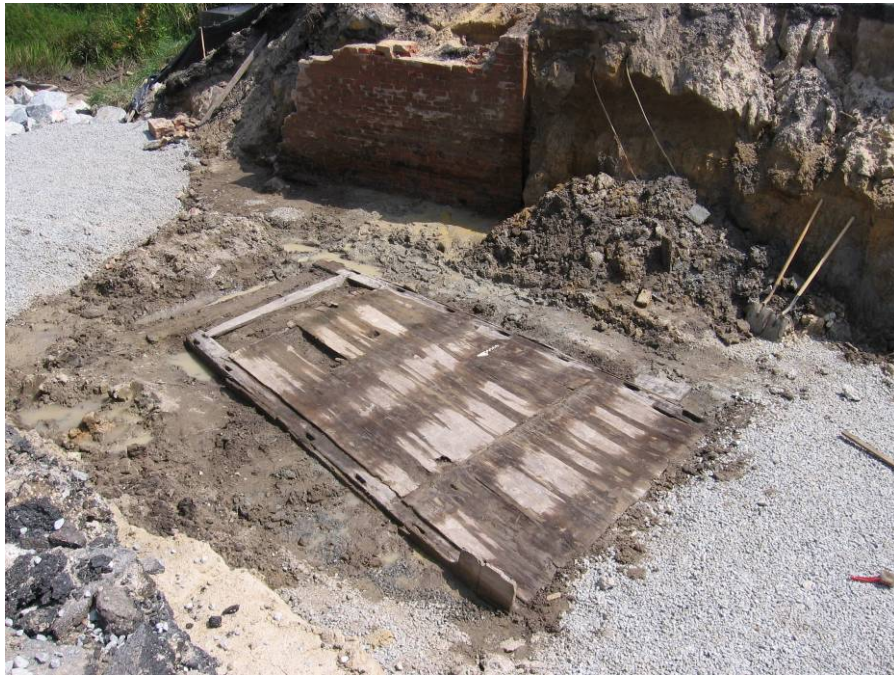
Photograph 7. East half of wood structure with large cross timbers removed to reveal plank surface, facing south/southeast.

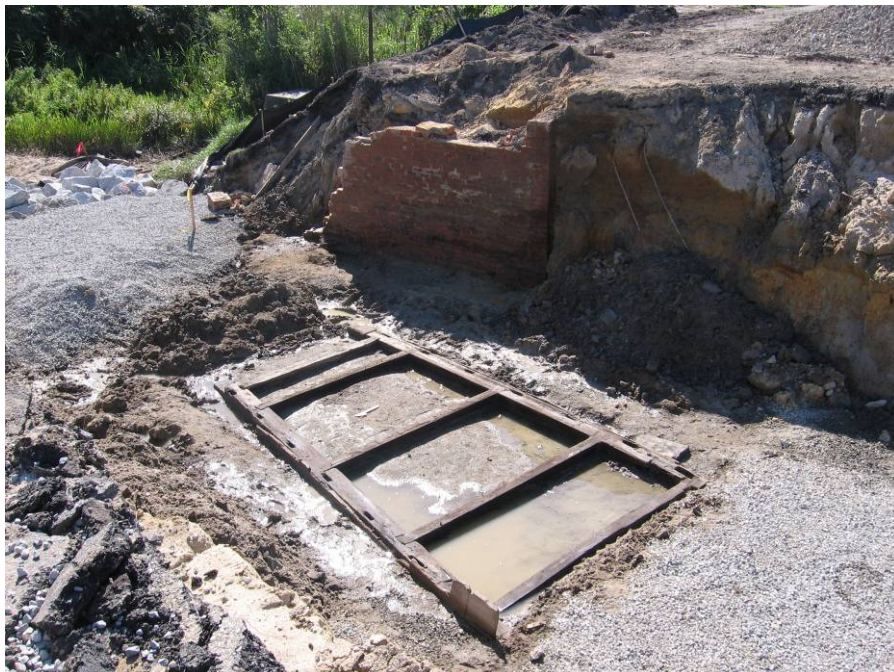
Photograph 8. East half of wood structure frame with planking removed, facing southeast.

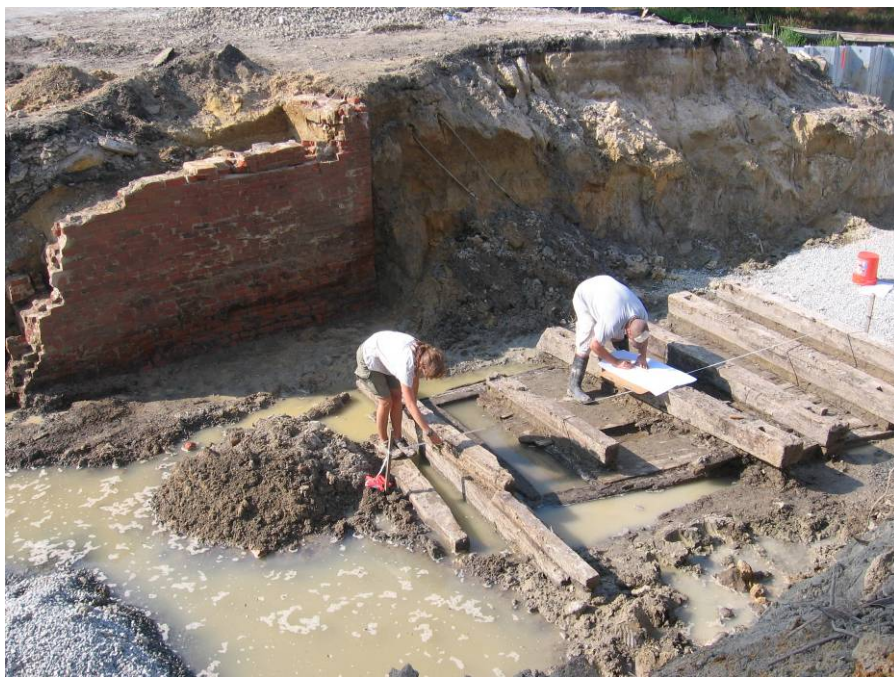
Photograph 9. Mapping east half of wood structure, facing south/southwest.

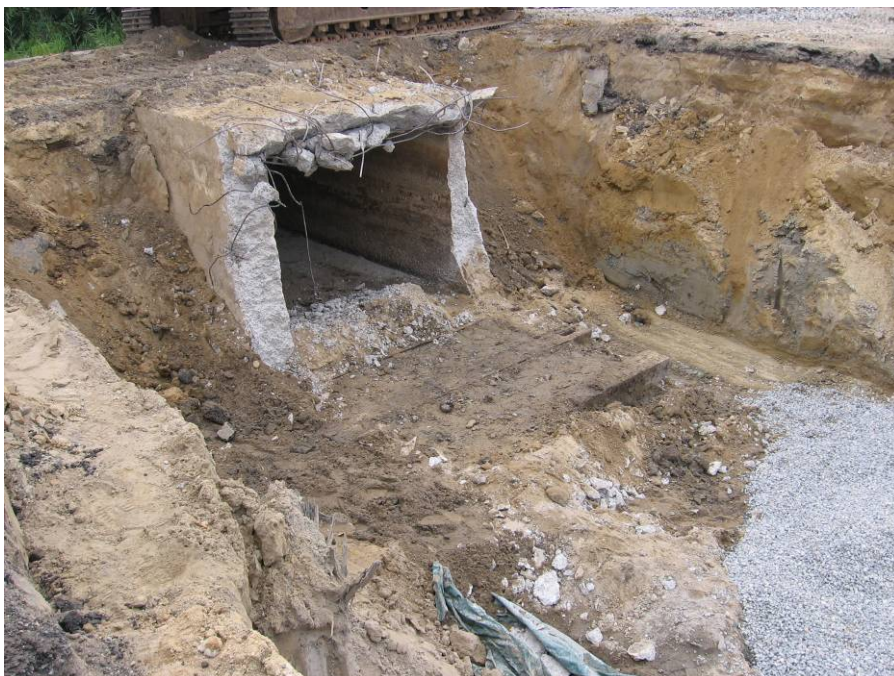
Photograph 10. West half of wood structure initial exposure during removal of ca. 1925 bridge and spillway, facing southeast.

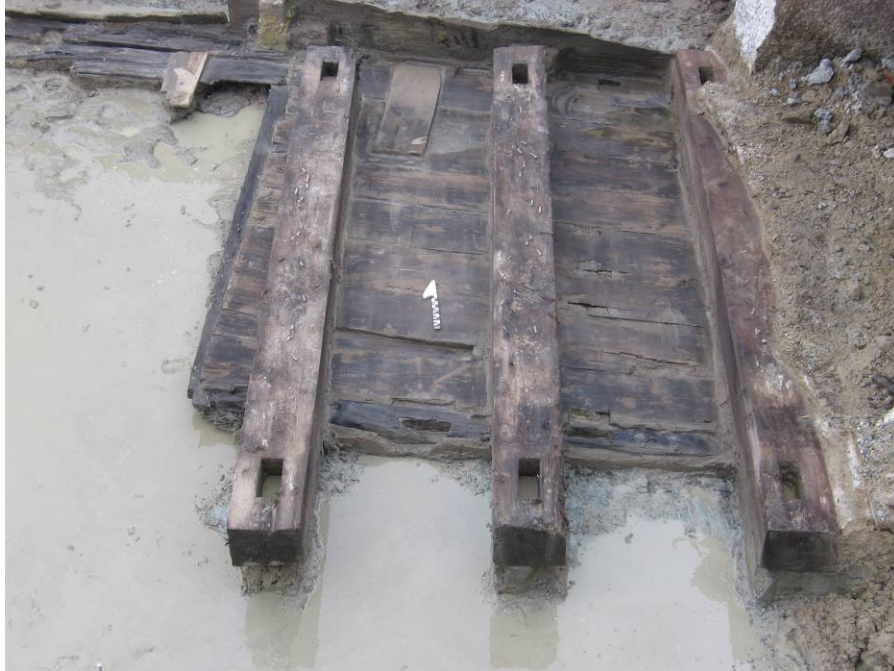
Photograph 11. West half of wood structure after exposure, facing north.

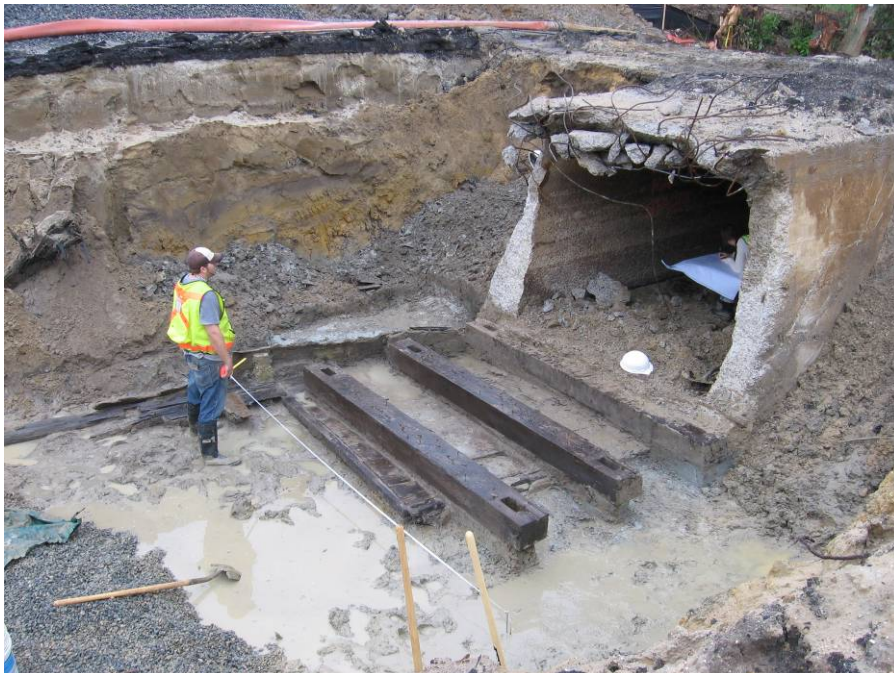
Photograph 12. Mapping west half of wood structure, facing northwest.

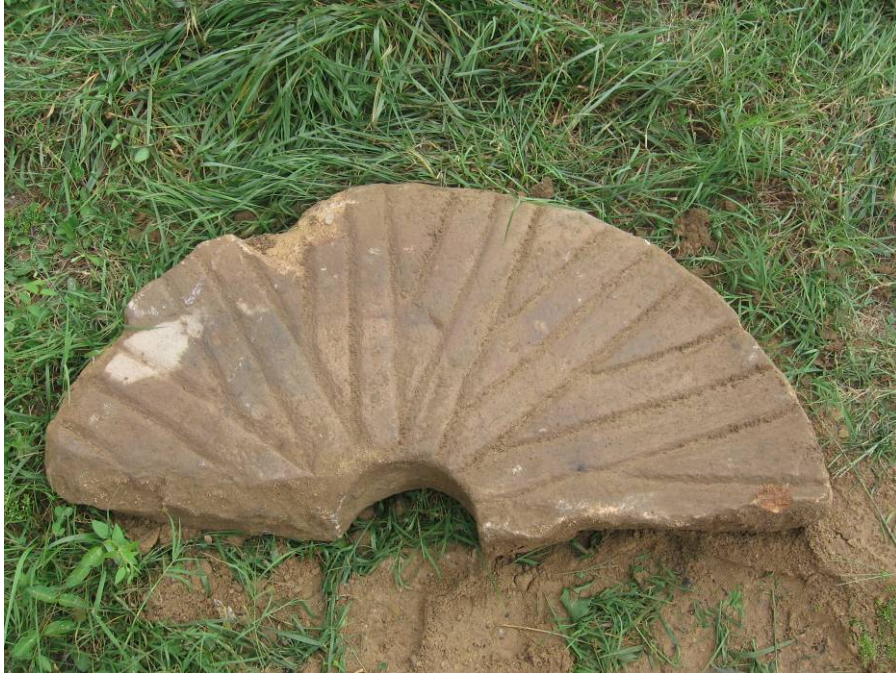
Photograph 13. Mill Stone No. 1 fragment.

which are large timbers or planks comprising the wood platform and frame structure. Objects include bottles, nails, timbers, planks, and mill stones (Photographs 13-15).

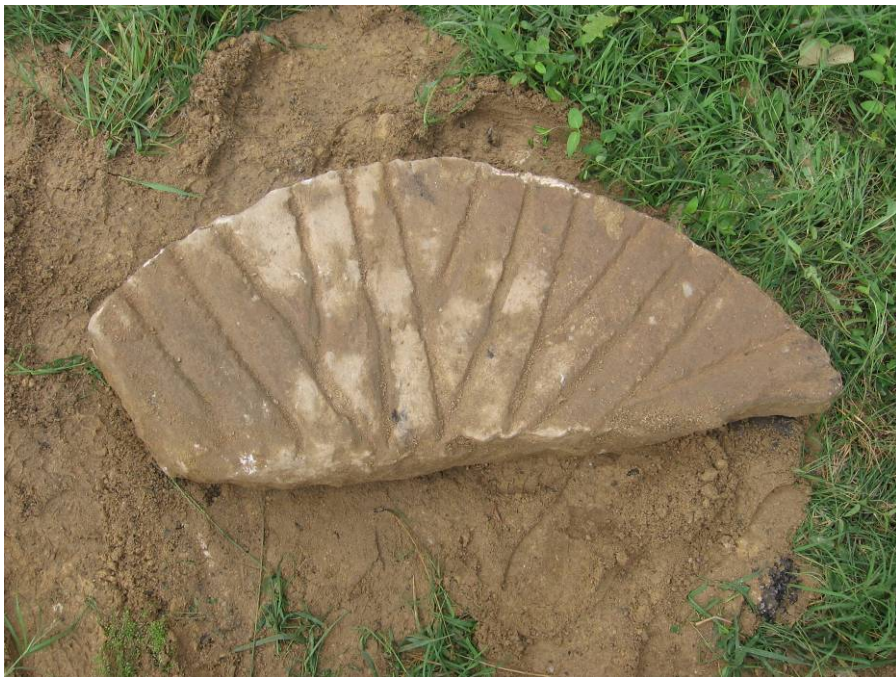
Photograph 14. Mill Stone No. 2 fragment.

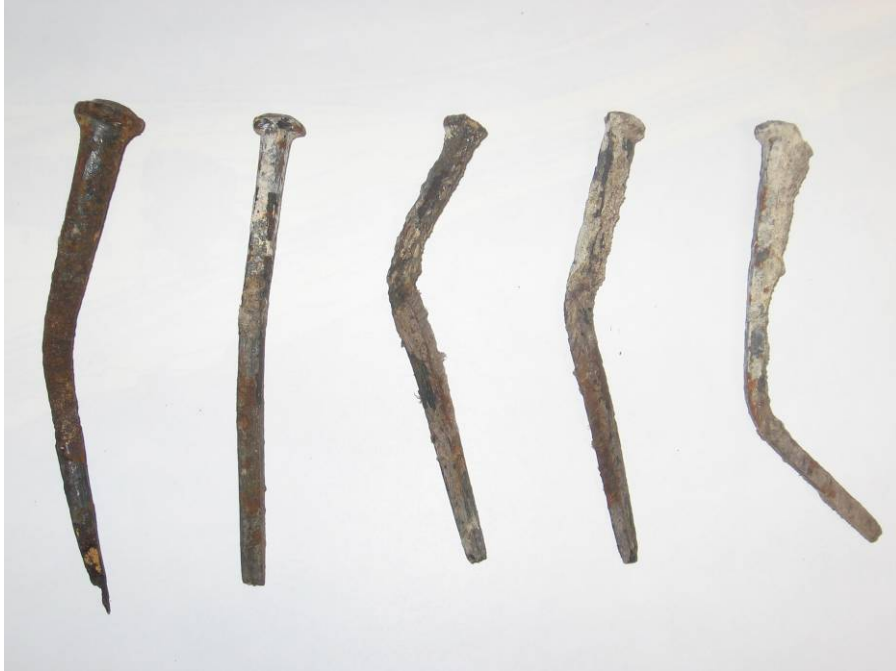
Photograph 15. Example of nails.
